BUILDING REPORT

Sample

13 February 2014

- Townhouse - semi detached
- Three bedrooms
- One bathroom and one ensuite

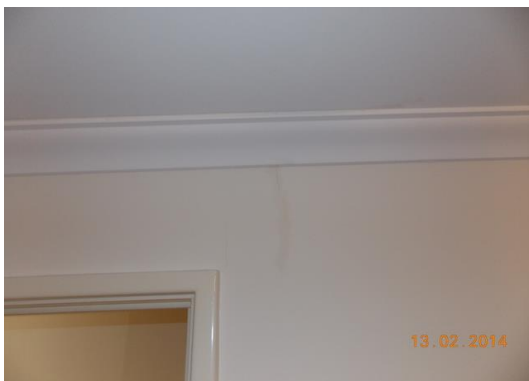
- Ceilings and Cornices - acceptable
 - there is some minor movement cracking along the cornice lines
- Wall Finish Interior - acceptable
 - There is some minor cracking in the plastered walls. The cracks were not considered structurally significant at the time of inspection; however cracks should be monitored to determine if the problem is ongoing
- Windows - Internal - acceptable
- Doors - Internal - acceptable
- Robe Shelves/doors - acceptable
- Floor Coverings - acceptable
 - carpet
- Skirting Boards - acceptable
- Painting – acceptable

Minor wall crack

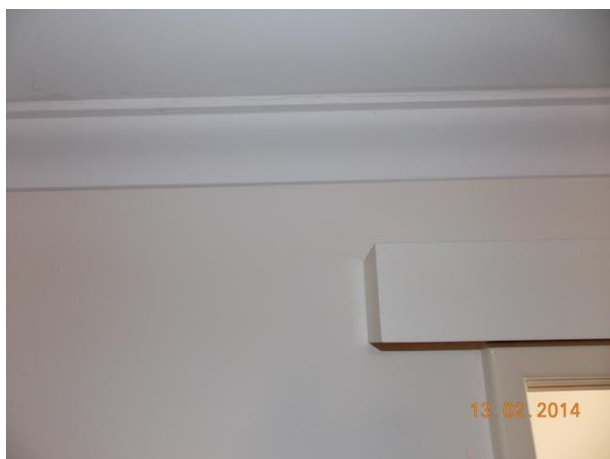
- Ceilings and Cornices - acceptable
 - there is some minor movement cracking along the cornice lines
- Wall Finish Interior - acceptable
 - There is some minor cracking in the plastered walls. The cracks were not considered structurally significant at the time of inspection; however cracks should be monitored to determine if the problem is ongoing
 - Some plaster cracking was observed under the cornice line. This has caused the plaster to be drummy due to loss of adhesion. This is not structural and minimal maintenance is required prior to repainting
- Windows - Internal - acceptable
- Doors - Internal - acceptable
- Robe Shelves/doors - acceptable
- Floor Coverings - acceptable
 - carpet
- Skirting Boards - acceptable
- Painting - acceptable

Minor wall crack

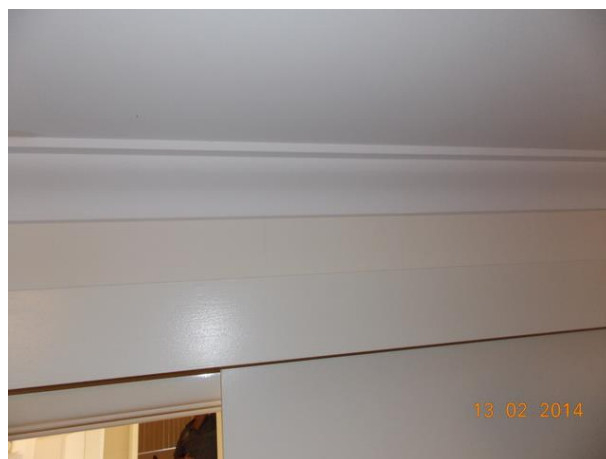
Minor wall crack

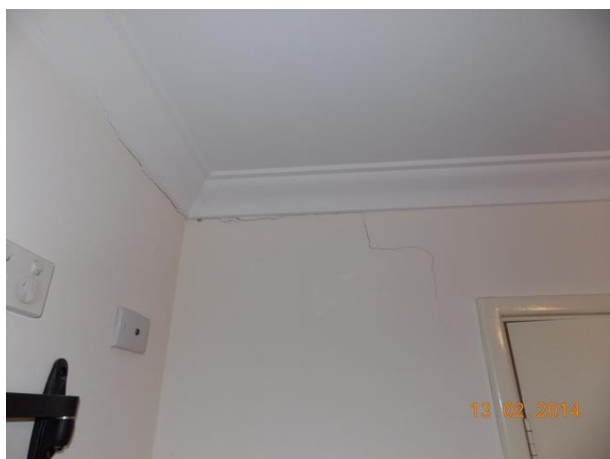
Wall crack

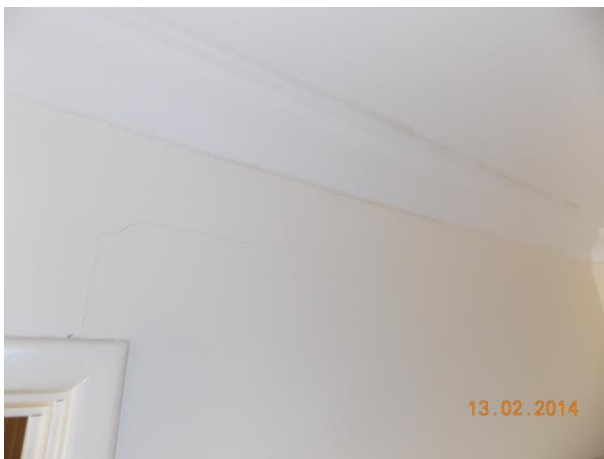
- Ceilings and Cornices - acceptable
- Wall Finish Interior - acceptable/fair
 - There is some minor cracking in the plastered walls. The cracks were not considered structurally significant at the time of inspection; however cracks should be monitored to determine if the problem is ongoing
- Doors - Internal - acceptable
- Windows - Internal - acceptable
- Shower Screen - not applicable
- Vanity/Hand Basin - acceptable
- Toilet Suite - acceptable
 - dual flush plastic cistern
- Mirrors - acceptable
- Wall Tiles - acceptable
- Floor Tiles - acceptable
- Ventilation - acceptable
 - ventilation is provided by a ceiling mounted exhaust fan
- Water Leakage -
 - our visual inspection has not detected any water leakage
- Painting - acceptable

Minor wall crack

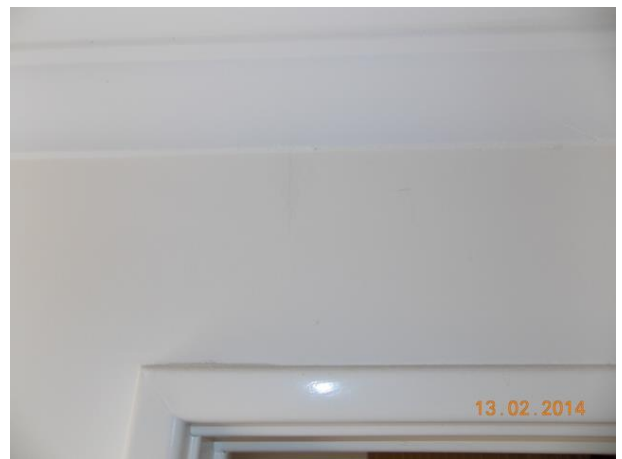
Minor wall crack
